**Sisson Project:**

**Baseline Aquatic Field Surveys of the Corridor  
for the Relocation of the Existing 345 kV  
Transmission Line and Fire Road**

Project No. 121810356  
February 4, 2013

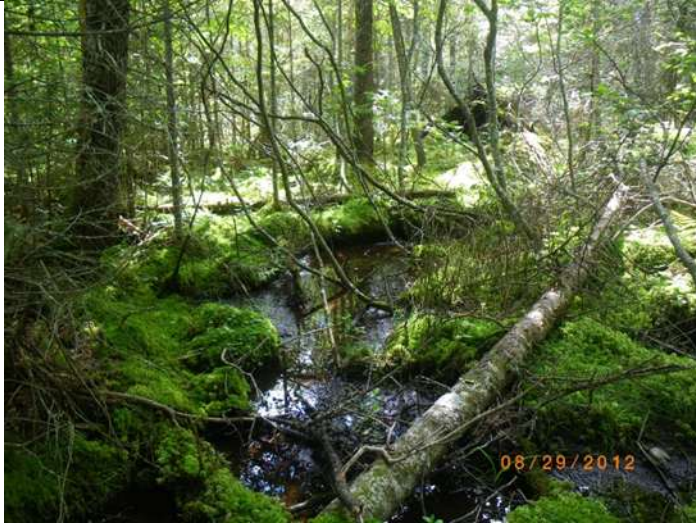
**Photo 1 Site 55 Habitat**

Site 55 consisted of a wetland with unconsolidated channel and very small amounts of occasional surface flow. The road crossing at the uppermost end of that watercourse had a small culvert, indicating that the watercourse does experience some amount of water during some parts of the year. Overall, this watercourse was intermittent and flowed underground approximately 100 m downstream of the upper boundary of the linear facilities corridor, and was determined to not be fish habitat (Photo 1).

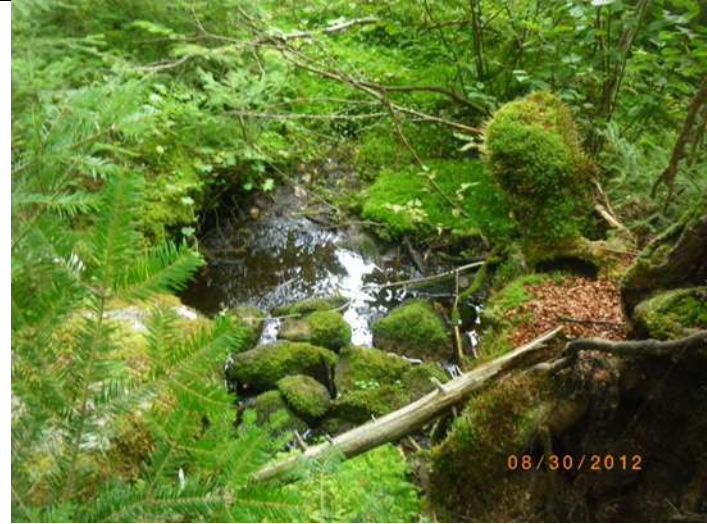
**Photo 2 Site 56 Habitat**

Standing water was present at site 56 but no defined channel for this watercourse was found in the linear facilities corridor (Photo 2).

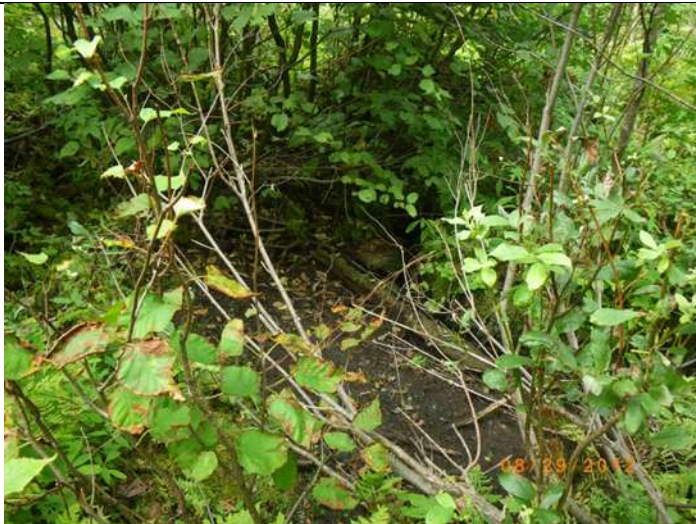
**Photo 3 Site 59 Habitat**

No water was present in the upstream portions of site 59 (Photo 3), but the mapped watercourse ended in a beaver pond approximately 30 m upstream of the border of the linear facilities corridor. However, no apparent watercourse was present in that vicinity.

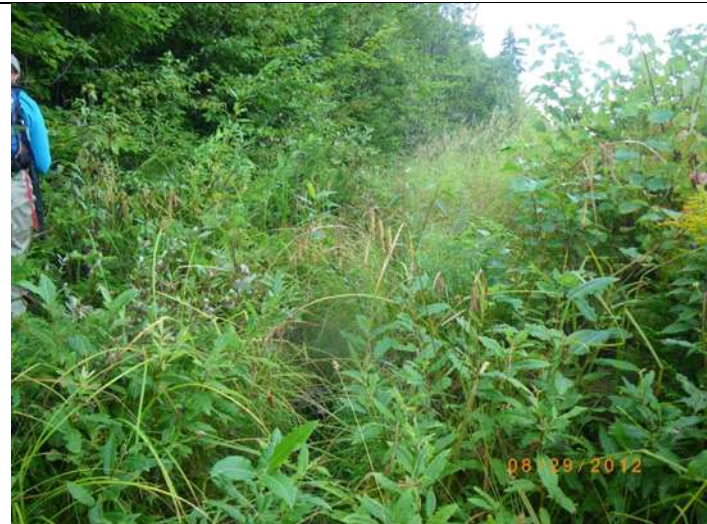
**Photo 4 Site 61 Habitat**

No watercourse was observed at the mapped location for site 61 inside of the linear facilities corridor study corridor, although hydrophytic wetland plant species were noted (Photo 4).

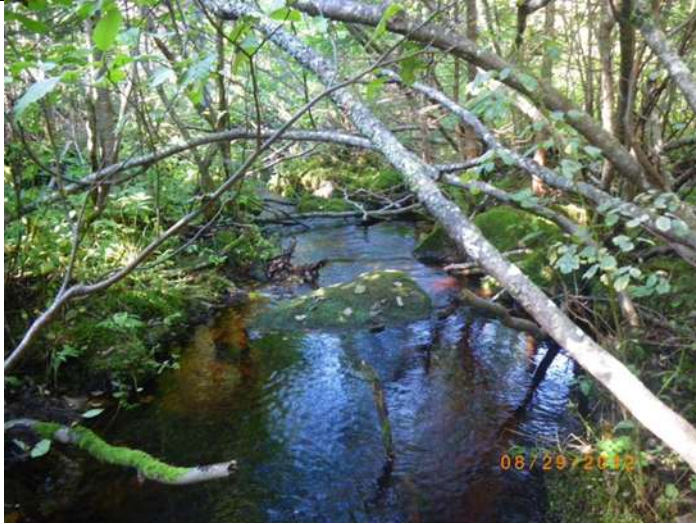
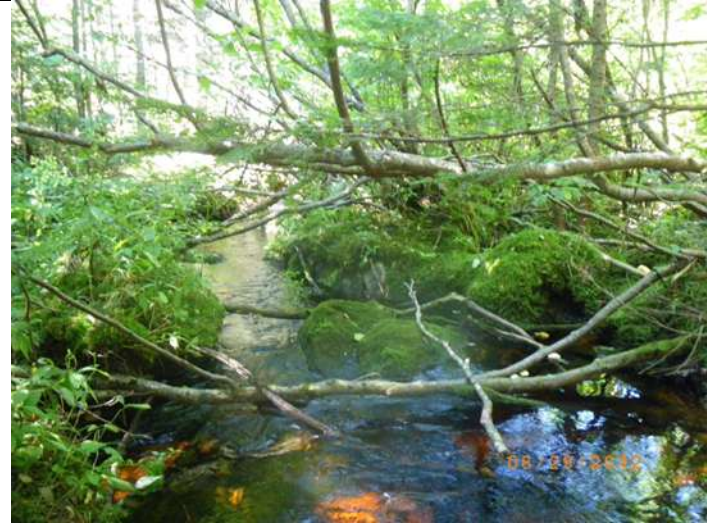
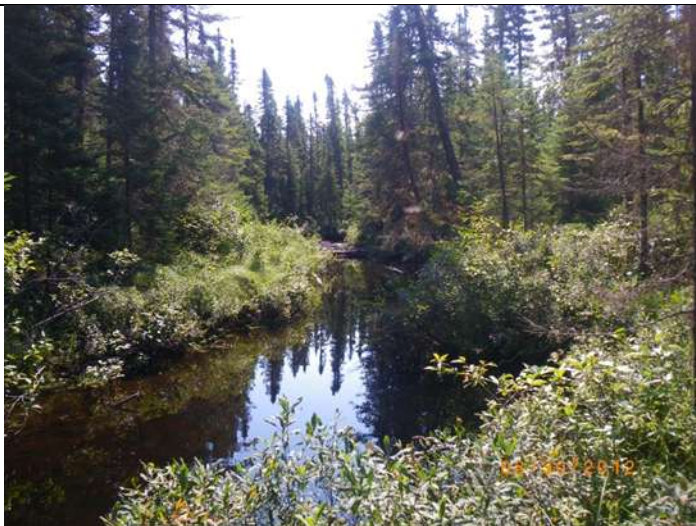
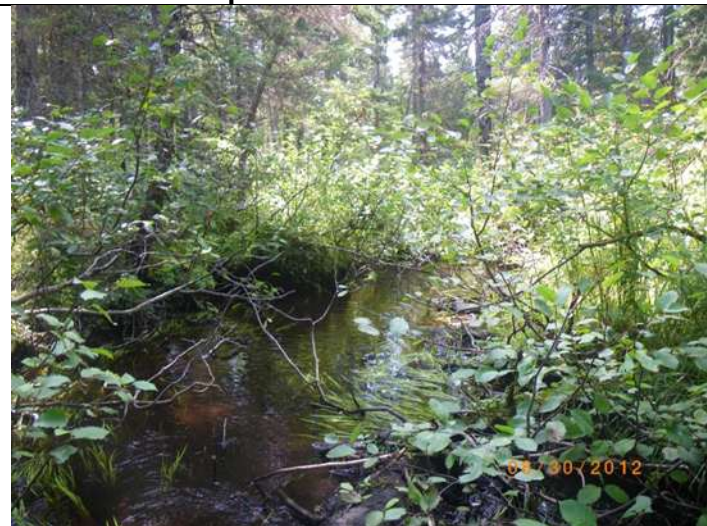
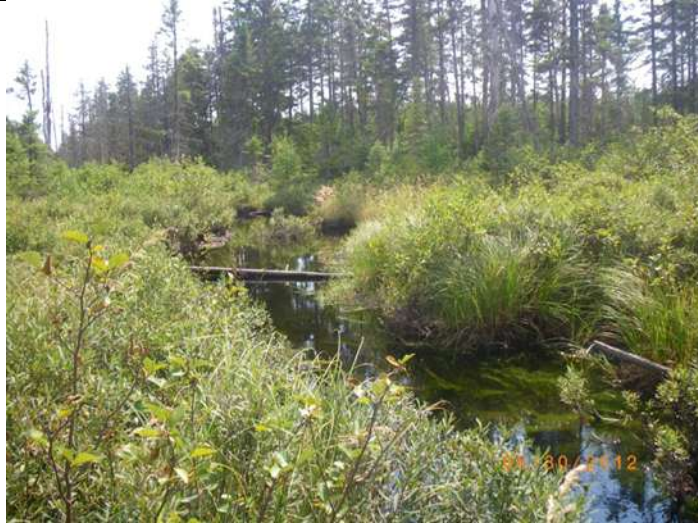
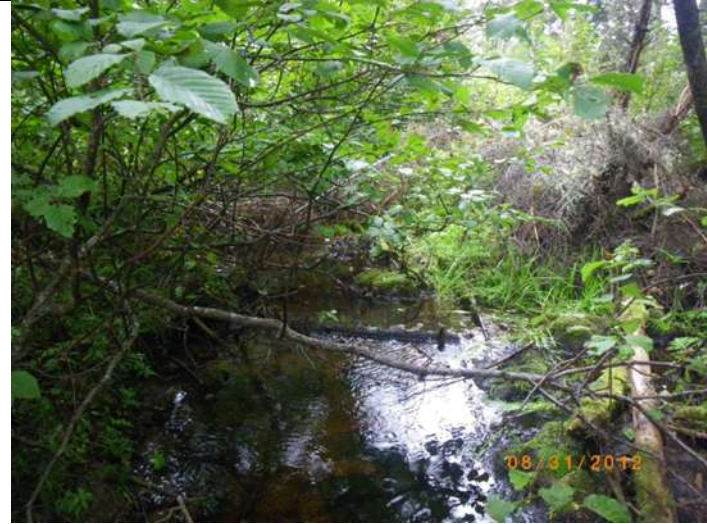
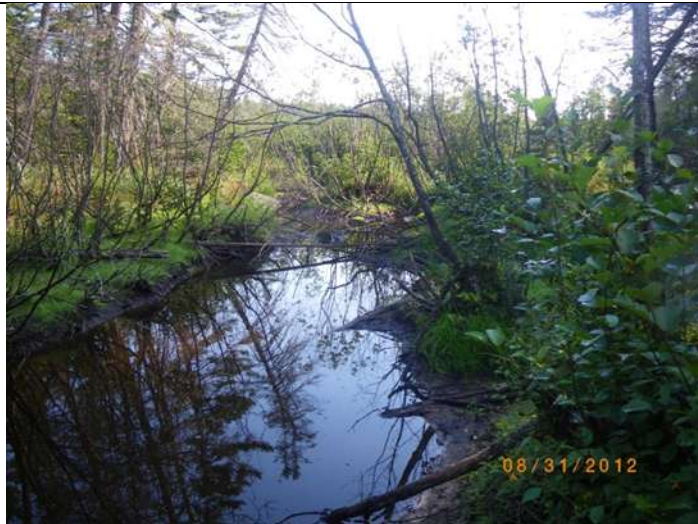
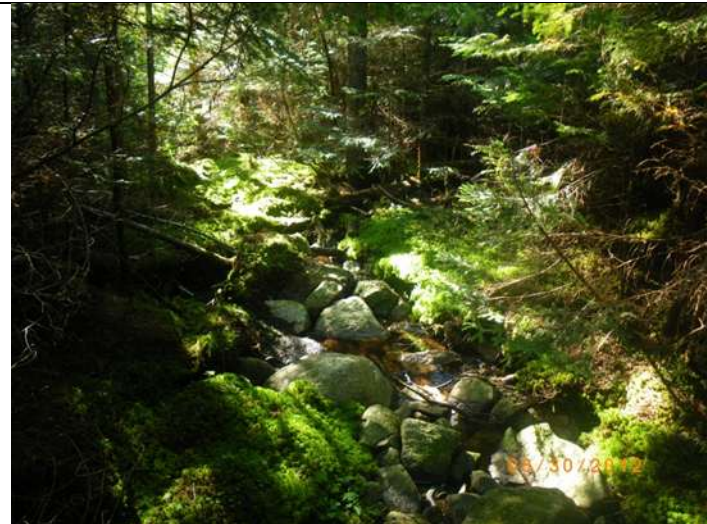
**Photo 5 Site 50 Downstream Habitat**

**Photo 6 Site 50 Upstream Habitat**

**Photo 7 Site 51 Downstream Habitat**

**Photo 8 Site 51 Upstream Habitat**

**Photo 9 Site 54 Habitat**

**Photo 10 Site 57 Downstream Habitat**

**Photo 11 Site 57 Upstream Habitat**

**Photo 12 Site 53 Habitat**

In general, the watercourses within the linear facilities corridor are small headwater streams, ranging from 1<sup>st</sup> to 3<sup>rd</sup> stream order (Photos 5 to 12). The streams are primarily second order, ranging from 2.0 to 5.3 m in width and 0.26 to 0.75 m in depth during bankfull conditions (Table 3.1). The substrate in the studied streams is primarily sand and fines, with abundant aquatic vegetation at sites that provide sufficient depth (Table 3.1). The condition of the stream channels is good, braided in parts and intermittent in headwater areas, flowing under and/or around boulders. Riparian vegetation is well established, with primarily grasses and shrubs providing approximately 50% shade. Dissolved oxygen levels ranged from 6.5 to 10.8 mg/L, and were typically above 8.5 mg/L (Table 3.2). Specific conductivity ranged from 20 to 39  $\mu$ S/cm and pH ranged from 5.8 to 6.6 (Table 3.2). Water temperatures ranged from 13.6 to 15.8°C, which can be considered cold for the time of sampling. Stream colour and transparency were similar between sites, slightly yellowish in colour with clear transparency (Table 3.1; Photos 13 to 19).

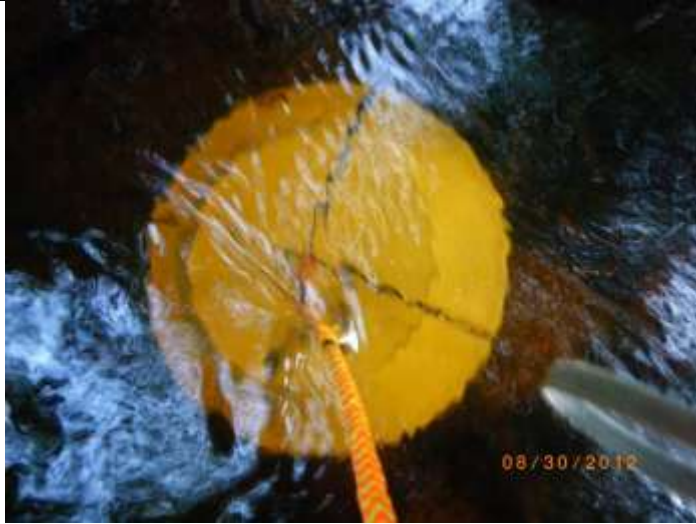
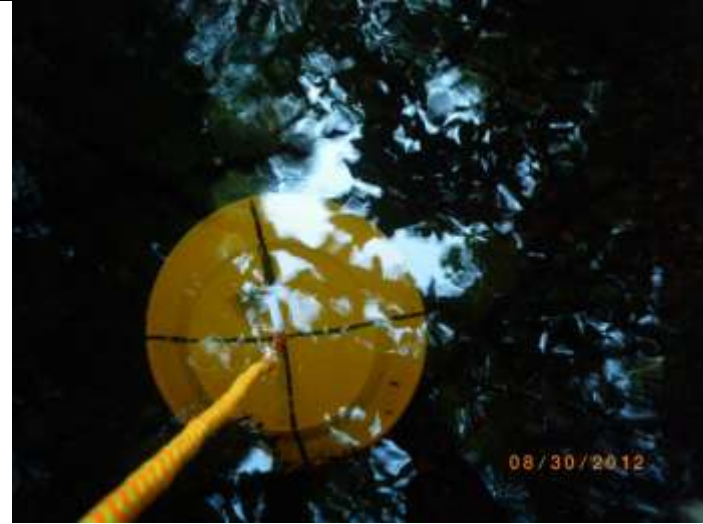
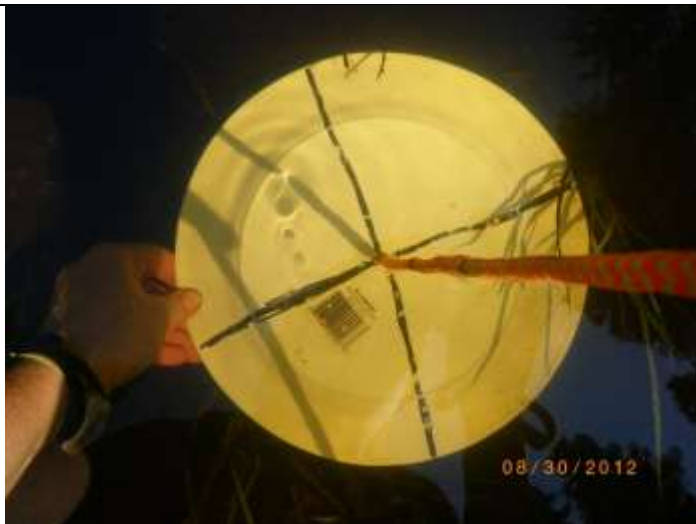
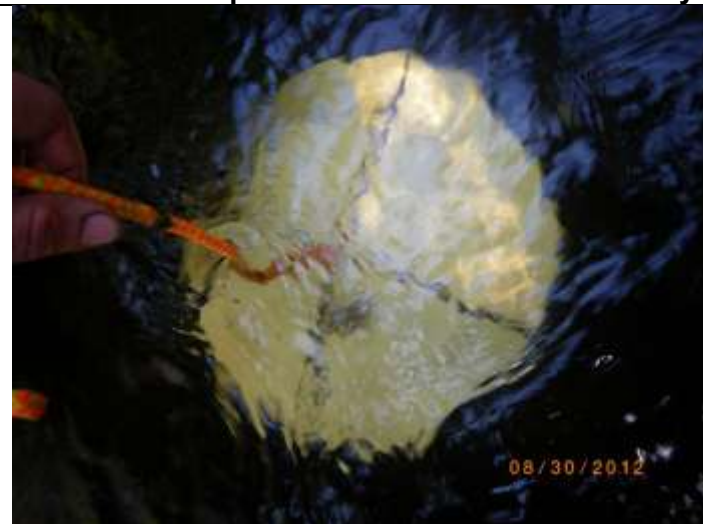
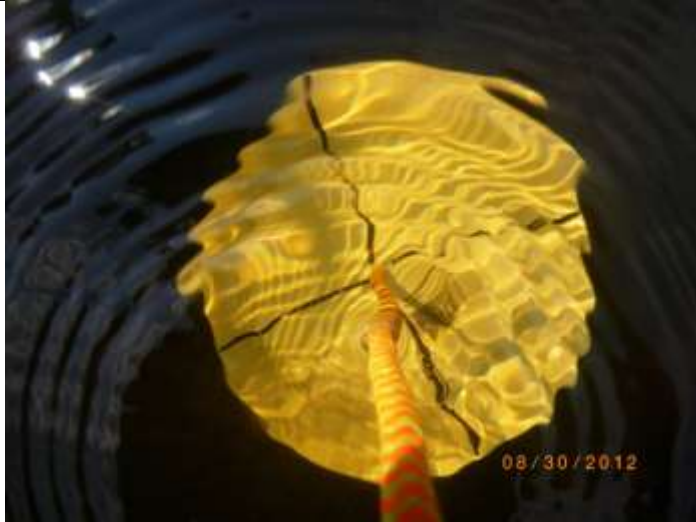
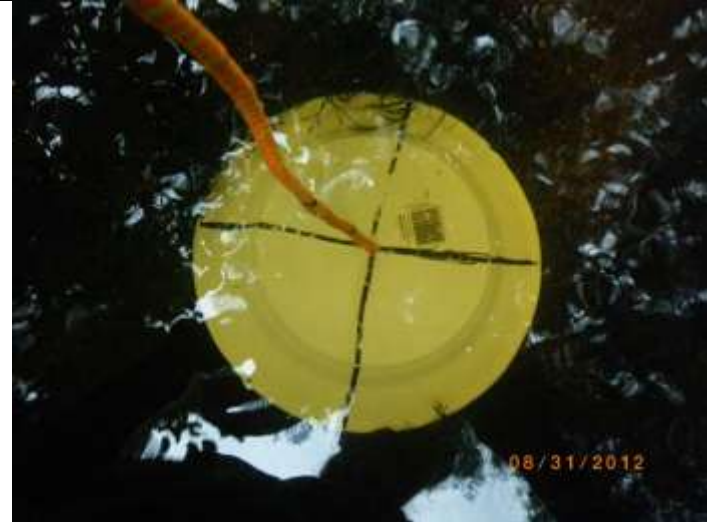
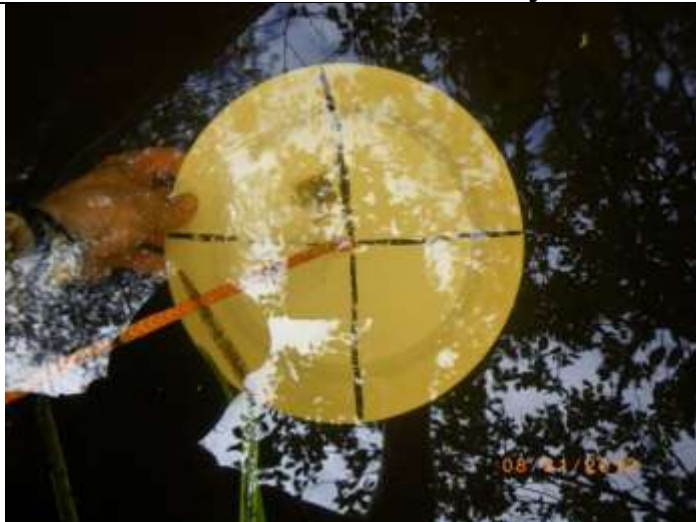
**Photo 13 Site 50 Downstream Water Colour and Clarity**

**Photo 14 Site 50 Upstream Water Colour and Clarity**

**Photo 15 Site 51 Downstream Water Colour and Clarity**

**Photo 16 Site 51 Downstream Water Colour and Clarity**

**Photo 17 Site 54 Water Colour and Clarity**

**Photo 18 Site 57 Downstream Water Colour and Clarity**

**Photo 19 Site 57 Upstream Water Colour and Clarity**

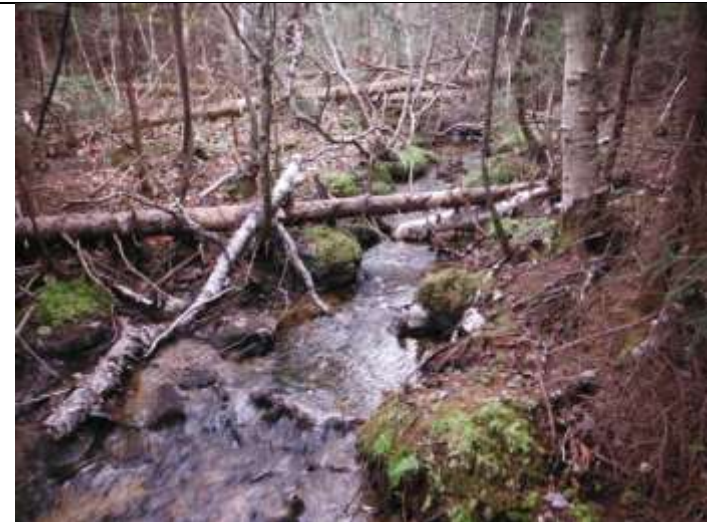
**Photo 20 Site 60 Habitat From Watercourse (59) Not as Mapped**

One watercourse (site 59) was not as mapped during the survey, and was identified during the wetland survey approximately 150 m northwest from watercourse 60 (Figure 2.1). The stream flowed approximately 300 m through the linear facilities corridor, and ended at the north end of a beaver pond. On August 29, 2012, wetland biologists measured that the stream was approximately 10 cm deep (wet depth), and on November 5, 2012, archaeology crews indicated that the stream was approximately 25-50 cm deep. The stream was 1 to 2 m in width. The substrate consisted primarily of sand, with a mix of some gravel, cobble, and rock (Photo 20). The photo of the unmapped watercourse was taken

on November 5, 2012 and is representative of higher flow conditions than were observed during the surveys of other watercourses in August. The riparian area was forested and contained abundant overhead cover. The channel condition was good, and well defined. Fish were observed in this stream by the wetland crews, but could not be identified for species.

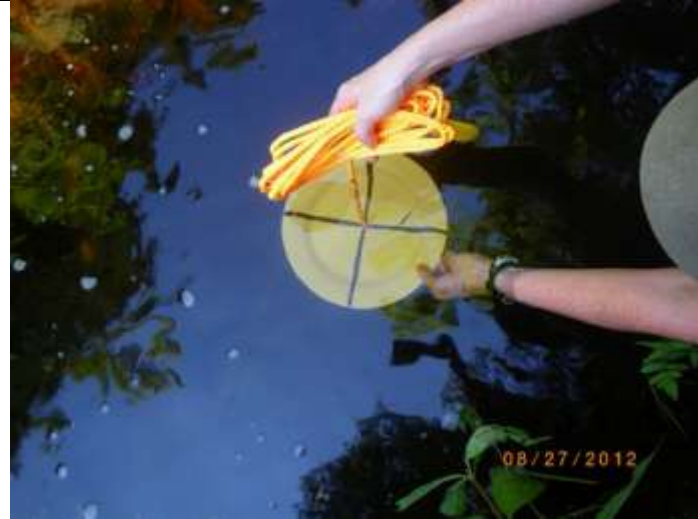
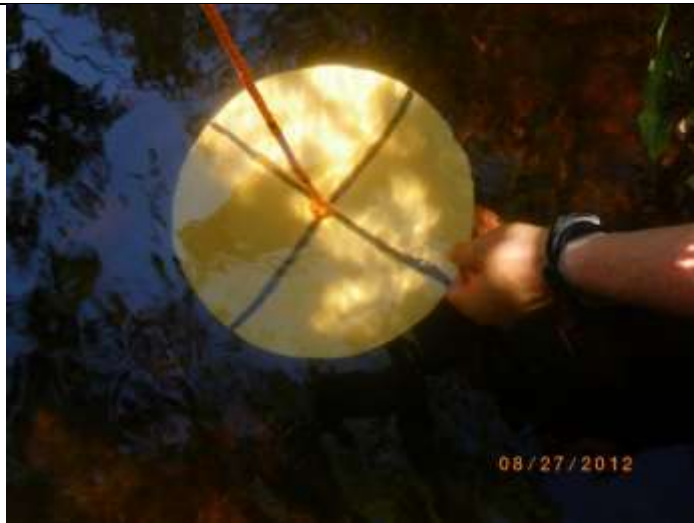
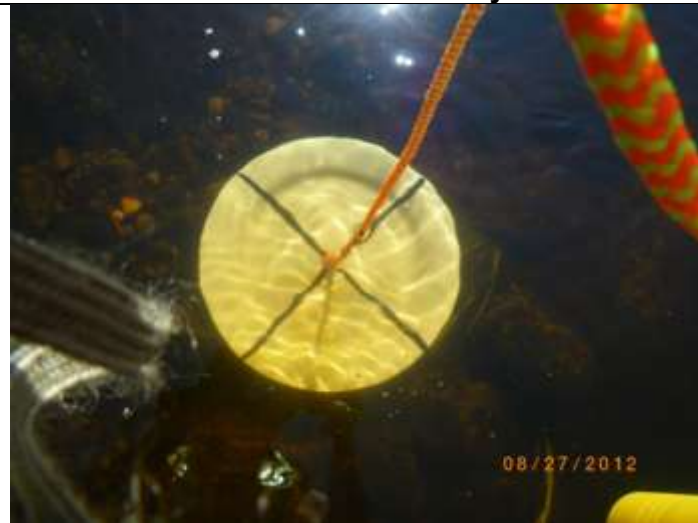
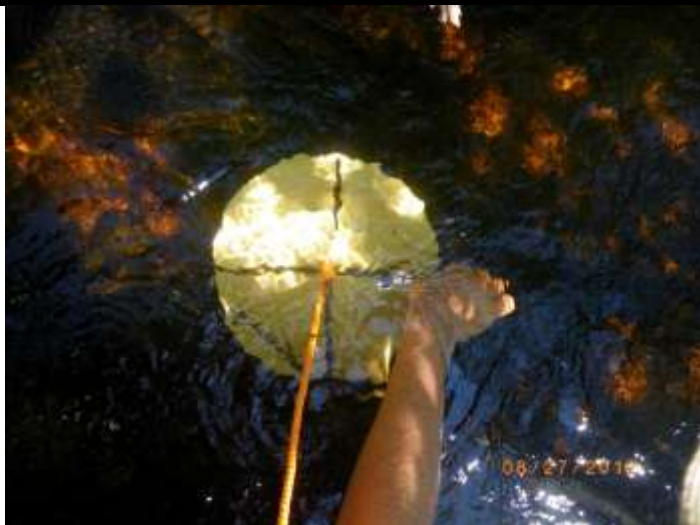
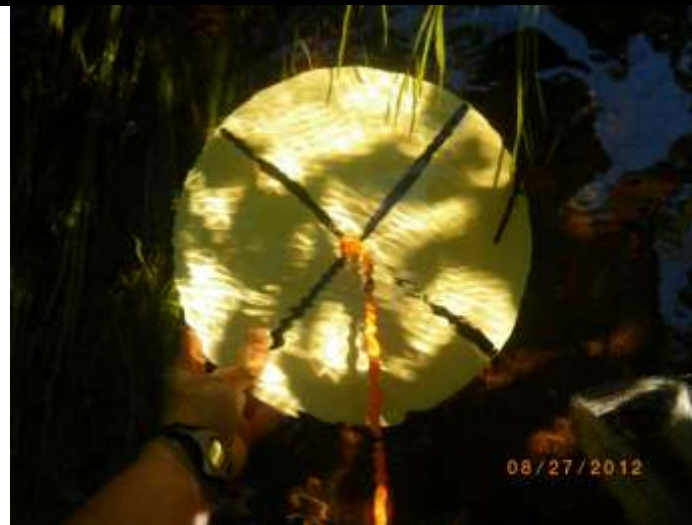
**Photo 26 51A Water Colour and Clarity**

**Photo 27 51B Water Colour and Clarity**

**Photo 28 51C Water Colour and Clarity**

**Photo 29 51D Water Colour and Clarity**

**Photo 30 51E Water Colour and Clarity**

The watercourse which paralleled the linear facilities corridor was a 3<sup>rd</sup> order stream. It ranged from 1.5 to 6.5 m in width and 0.34 to 0.70 m in depth during bankfull conditions (Table 3.3). The substrate is primarily sand, with some boulder and rock, with abundant aquatic vegetation at sites that provide sufficient depth (Table 3.3) (Photos 21 to 25). The channel is stable and well formed, of low gradient, and braided in parts. There is evidence of prior beaver activity as the stream flows through old beaver ponds and dams. Channel banks are well vegetated with grasses and shrubs, with approximately 50% shade. Dissolved oxygen levels ranged between 8.5 to 9.5 mg/L. Specific conductivity was 28.8 to 29.3 µS/cm and pH of 6.5 to 7.0 (Table 3.4). Temperature was warmer than the 1<sup>st</sup> and 2<sup>nd</sup> order tributaries, and ranged from 20.9 to 21.5°C. Stream colour was similar between sites, slightly yellowish in colour and clear (Table 3.3; Photos 26 to 30).
